NASA TECHNICAL
MEMORANDUM

NASA TM X-64844

MSFC SKYLAB NEUTRAL BUOYANCY SIMULATOR

14. SPONSORING AGENCY CODE	
15. SUPPLEMENTARY NOTES					
16. ABSTRACT Presented in this report is the role of the Neutral Buoyancy Simulator in the development, crew training, and flight operational aspects of Skylab.

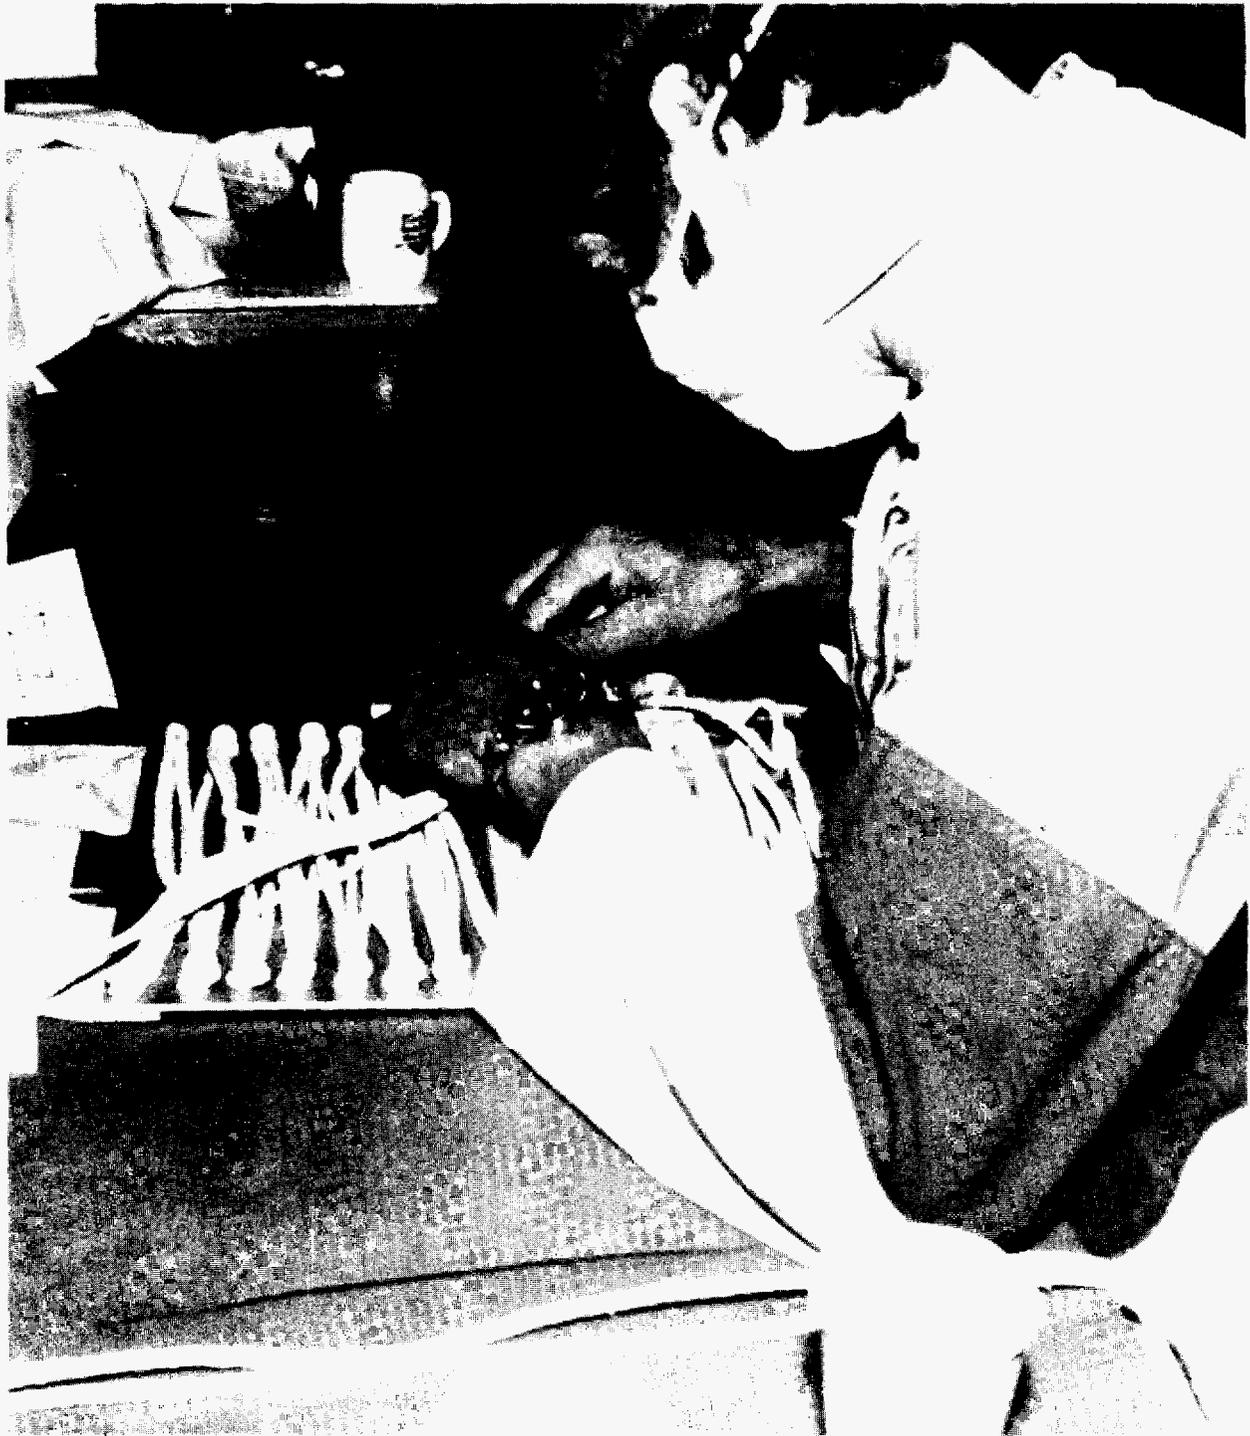
FIGURE 5-17 PACKING THE TWIN-POLE SAIL CLOTHESLINE

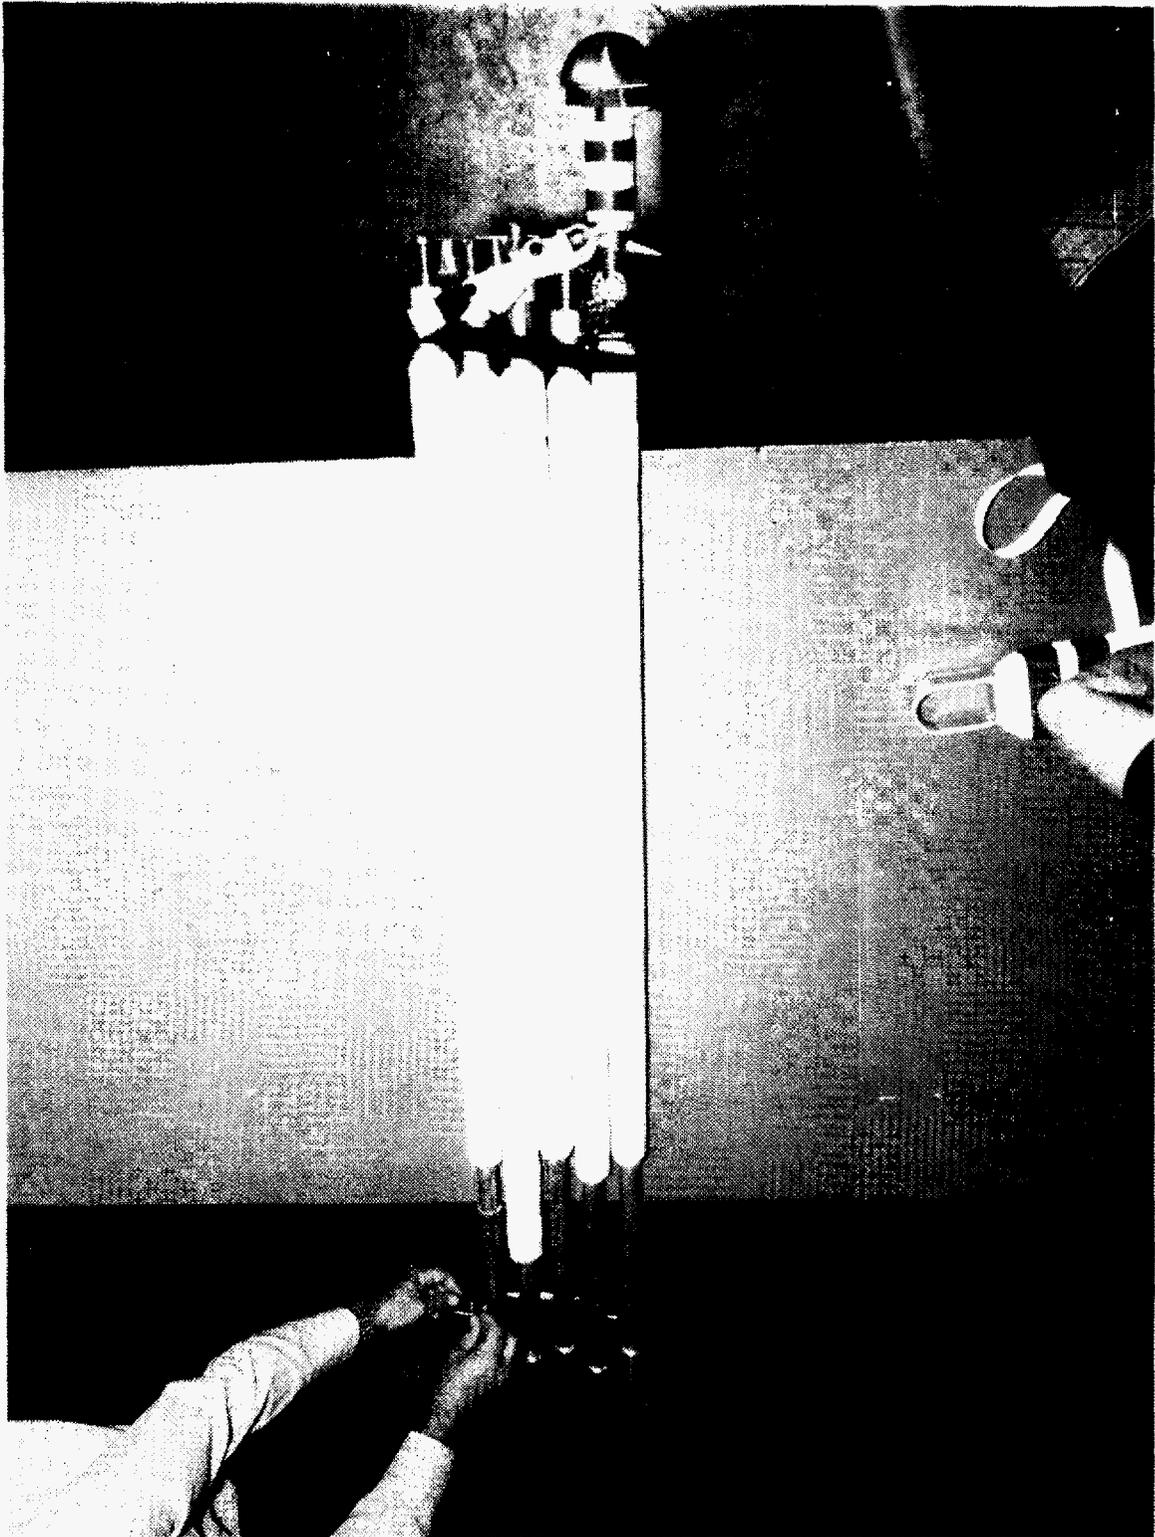
FIGURE 5-21 MSFC SAIL POLES (5) WITH MUSHROOM HEAD

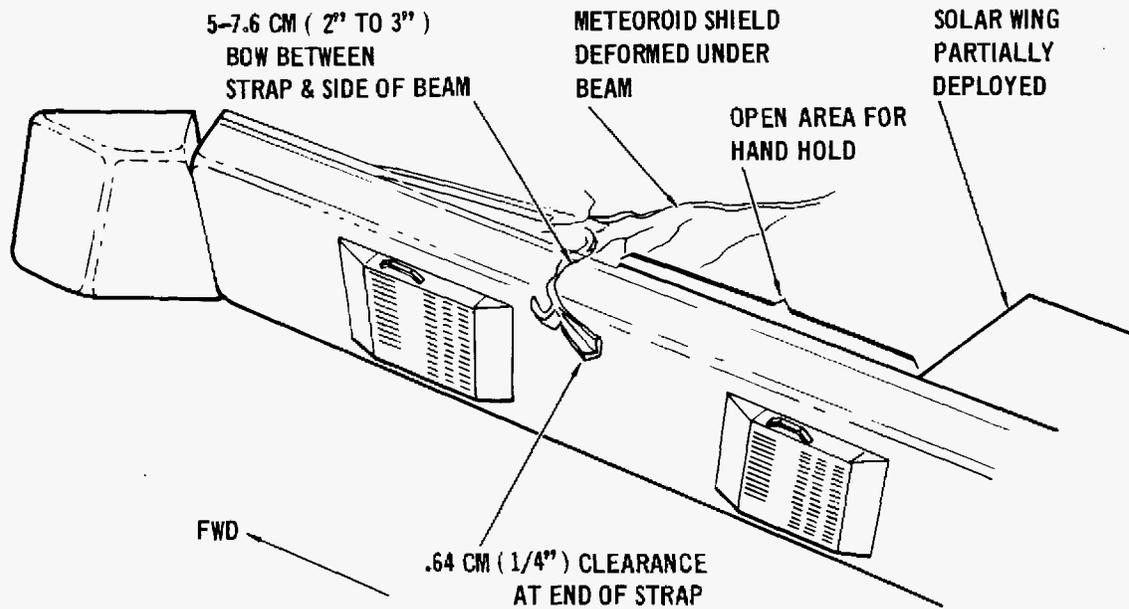
FIGURE 5-24 CONFIGURATION OF SAS WING NO. 1 PER TELECON WITH CREW - CDT 1430 6/1/73

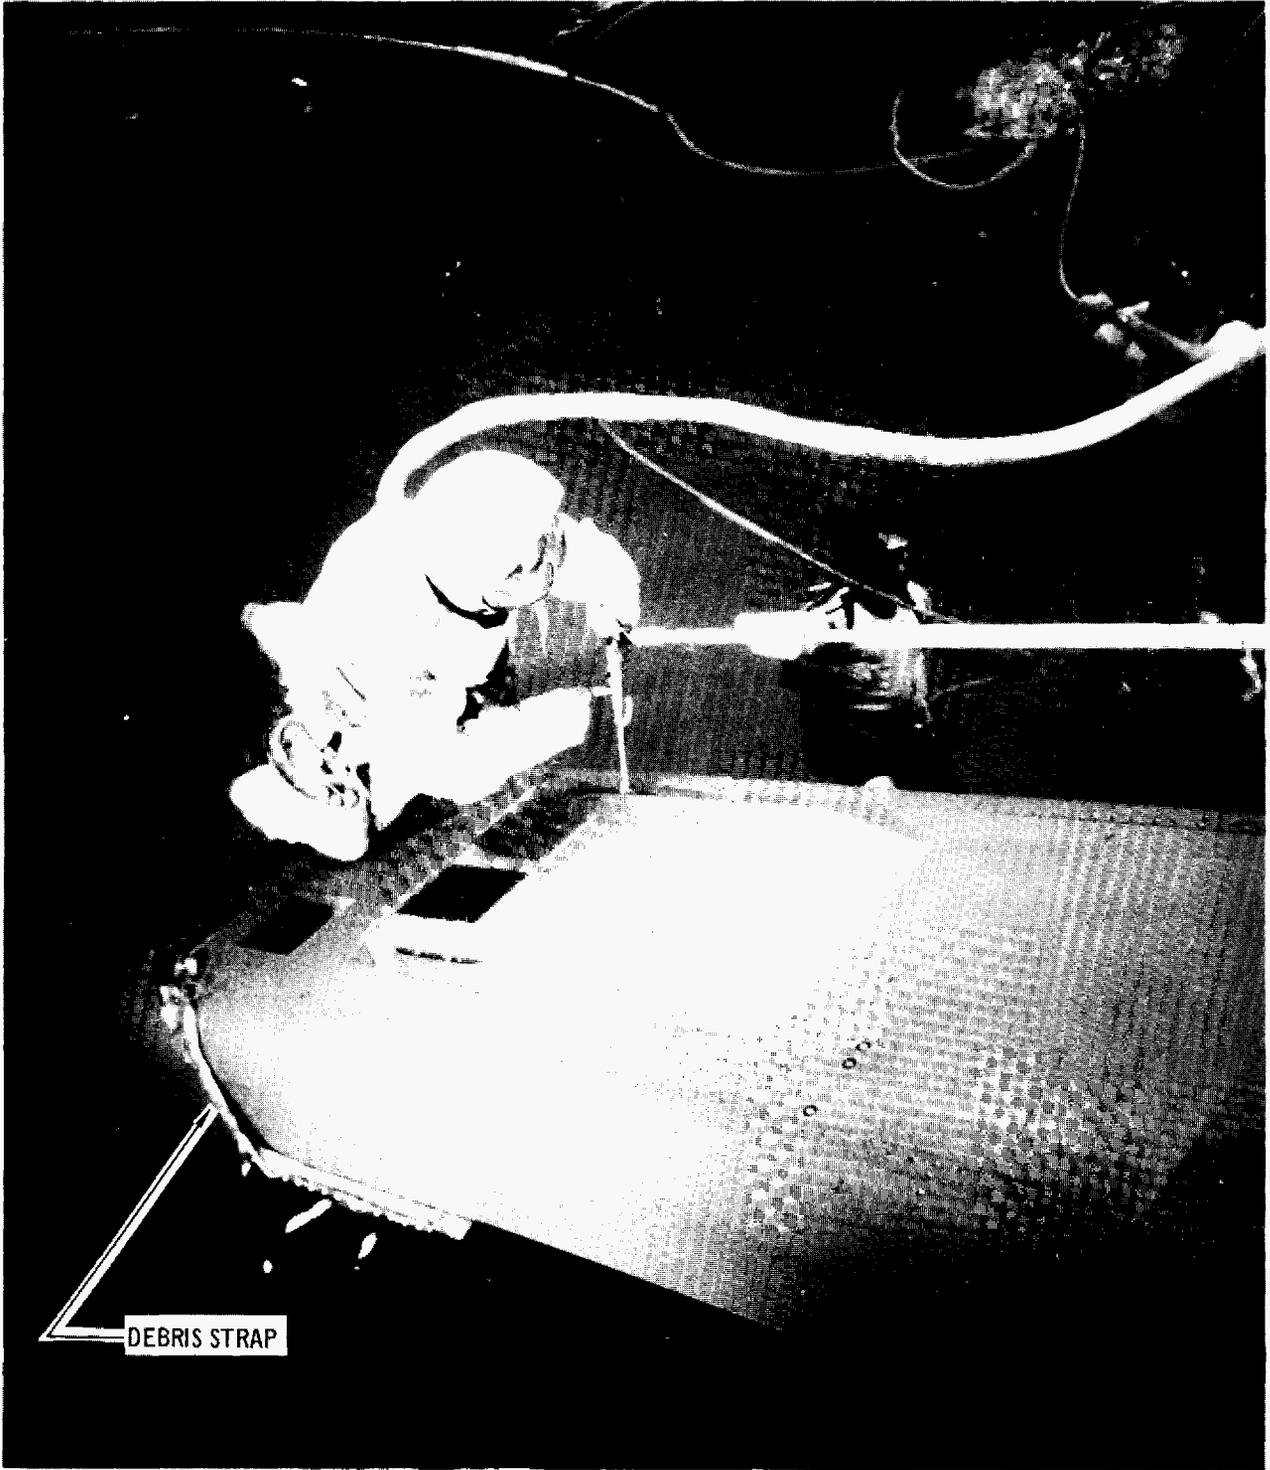
FIGURE 5-27 NBS SAS WING MOCKUP WITH DEBRIS STRAP

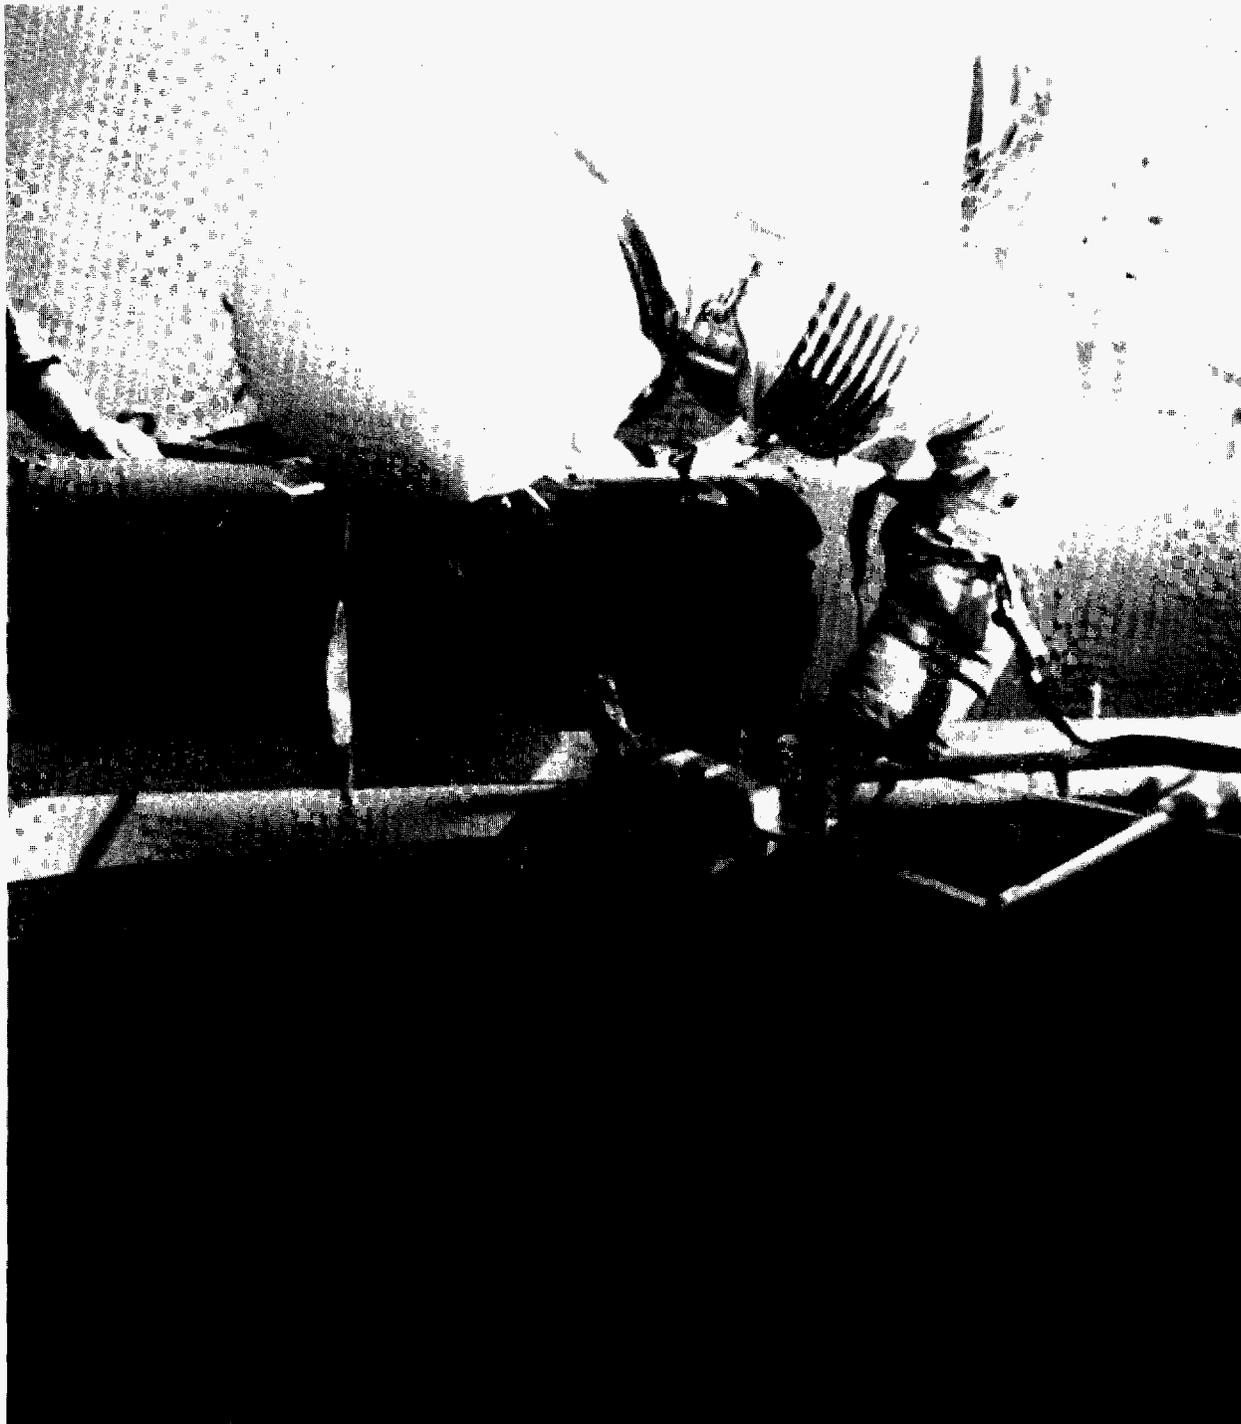
FIGURE 5-35 CUTTING DEBRIS STRAP WITH CABLE CUTTERS

The method for freeing the debris strap from the SAS wing was determined to be at the option of the EVA crewman: (1) cut with cable cutters (Figure 5-35); (2) pry loose using the pry bar (Figure 5-36), or (3) saw with the dental bone saw (Figure 5-37).

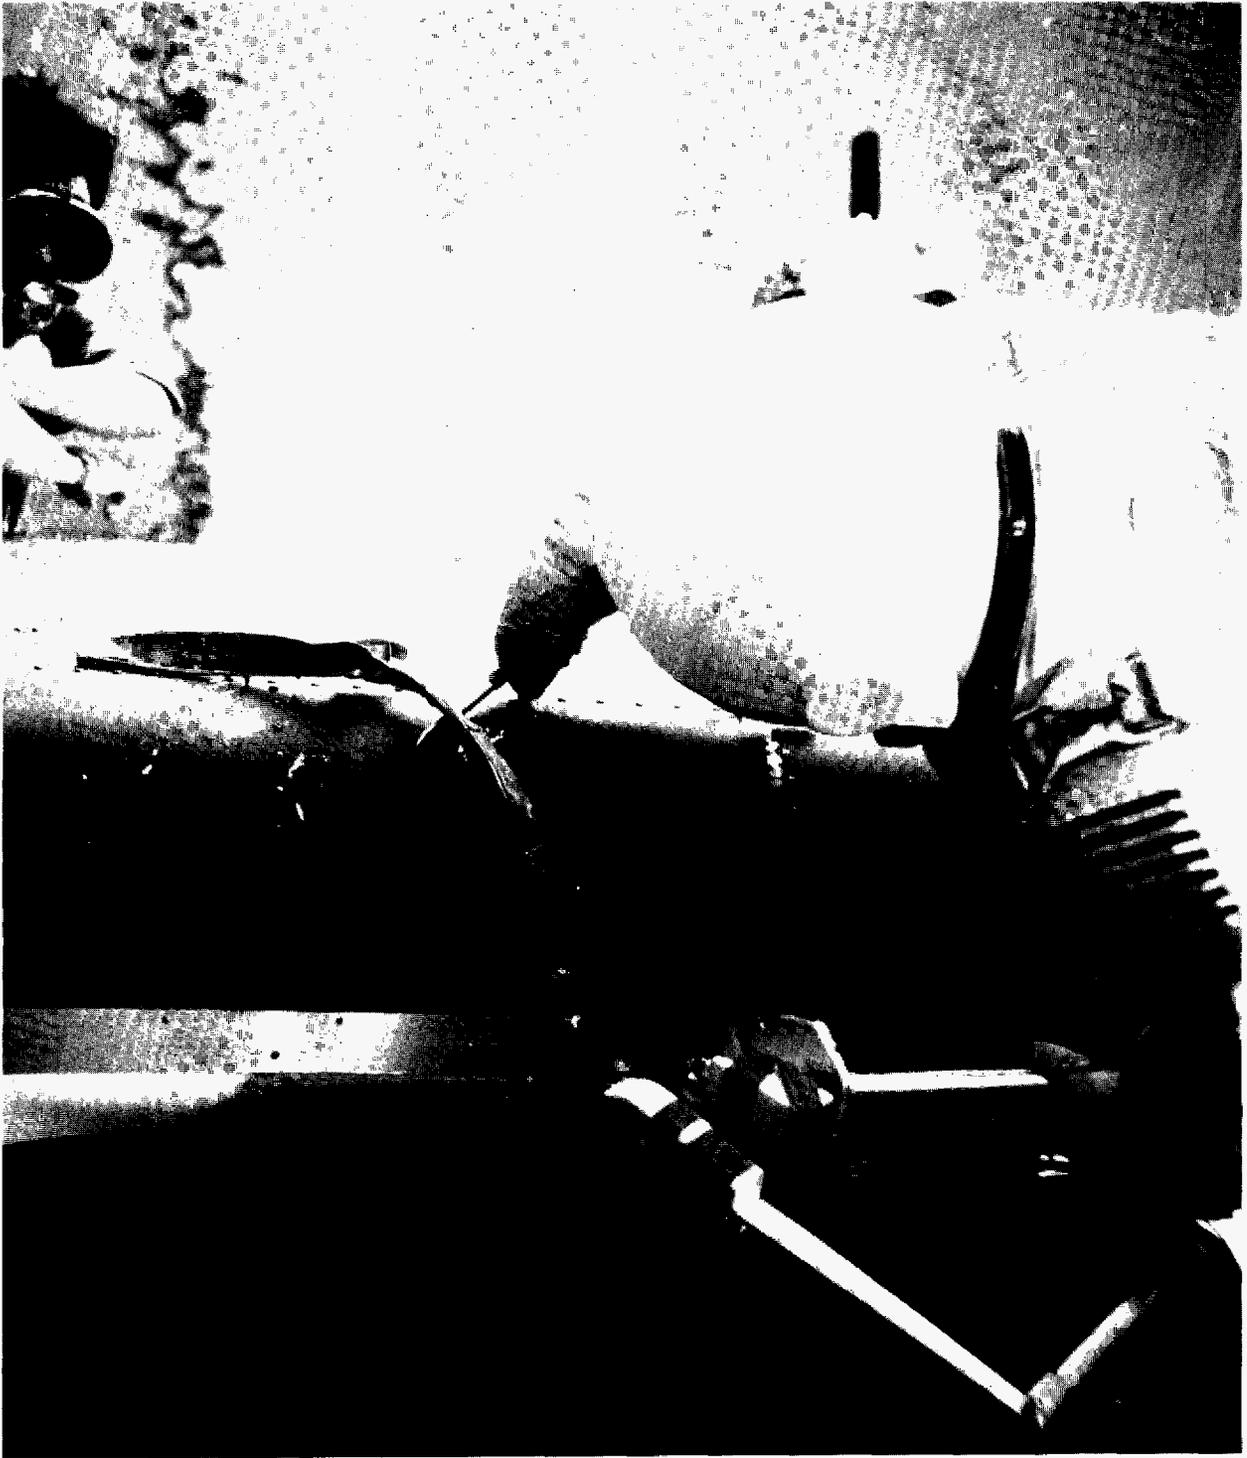
FIGURE 5-36 ASTRONAUT USING PRY BAR TO REMOVE SAS WING DEBRIS STRAP

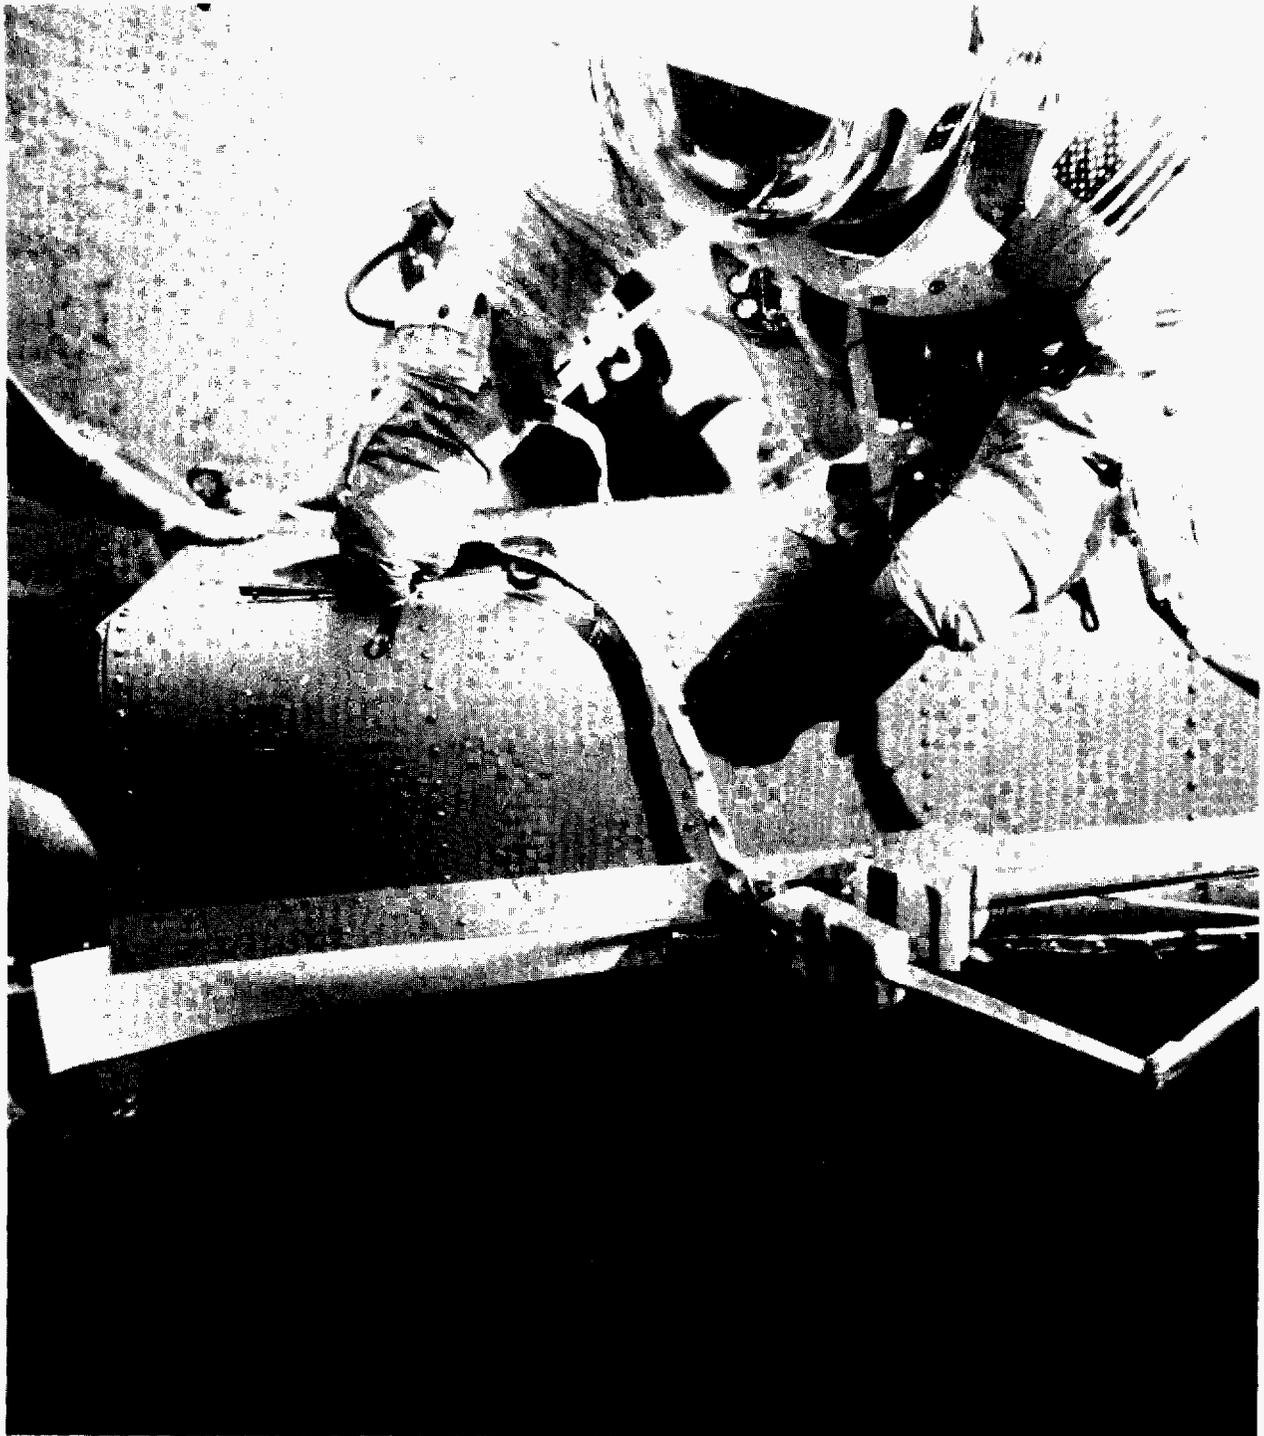
FIGURE 5-37 ASTRONAUT CUTTING DEBRIS STRAP WITH DENTAL BONE SAW

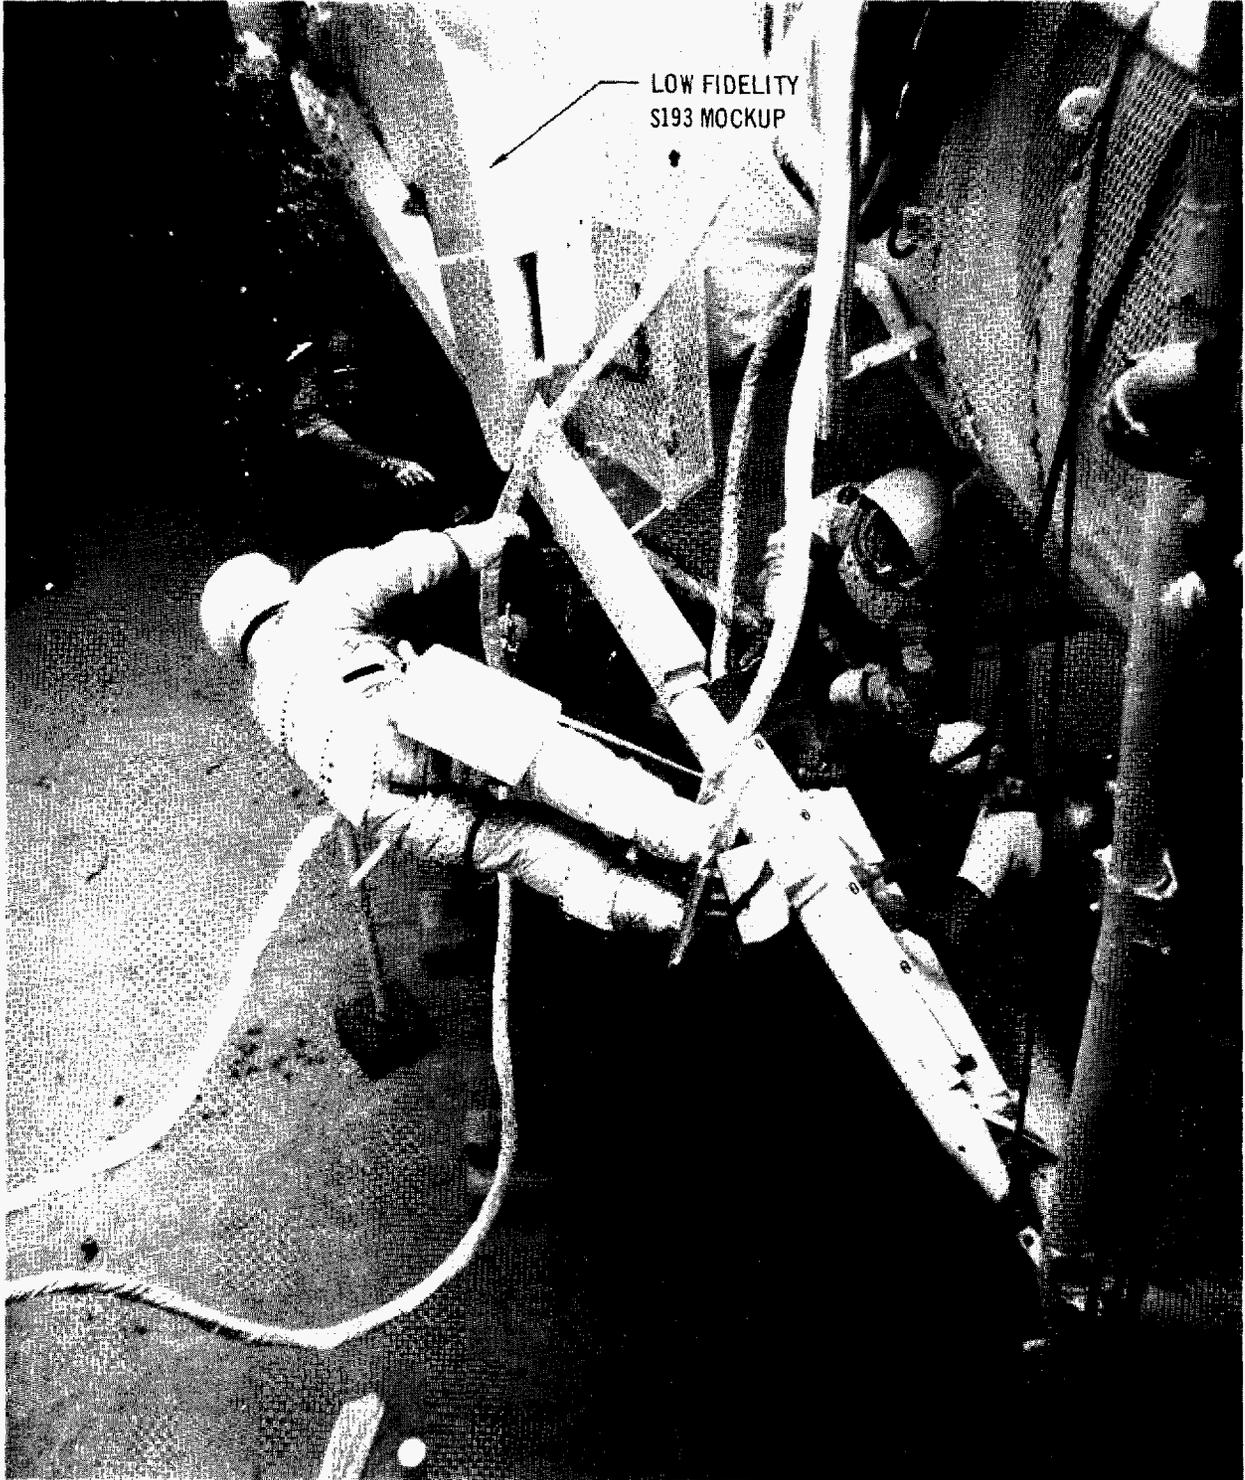
FIGURE 5-44 EARLY NBS S193 REPAIR EVALUATION

Initial NBS exercises to evaluate repair techniques (shown in Figure 5-44) emphasized the need for better fidelity of S193 equipment, work station foot restraints, and a device for holding tools in an accessible position.
